# CONCRETE BUILDINGS – RESTORATION AND MAJOR REPAIRS: Effective Solutions for Challenging Problems

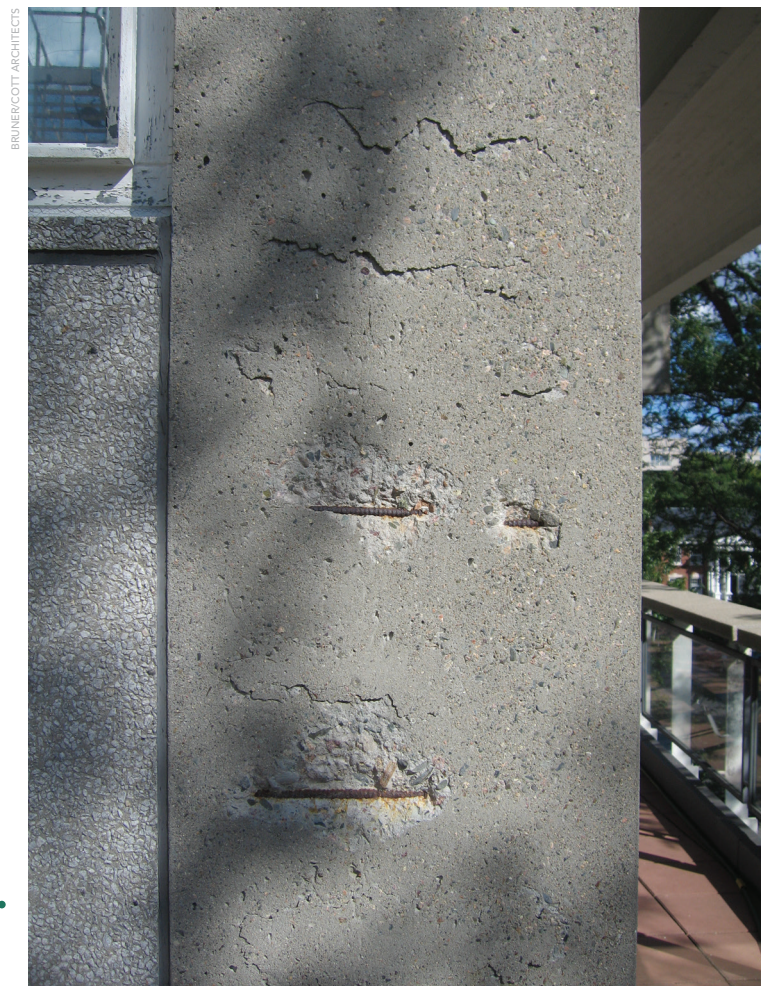
Cast-in-place and precast façades at Boston University School of Law

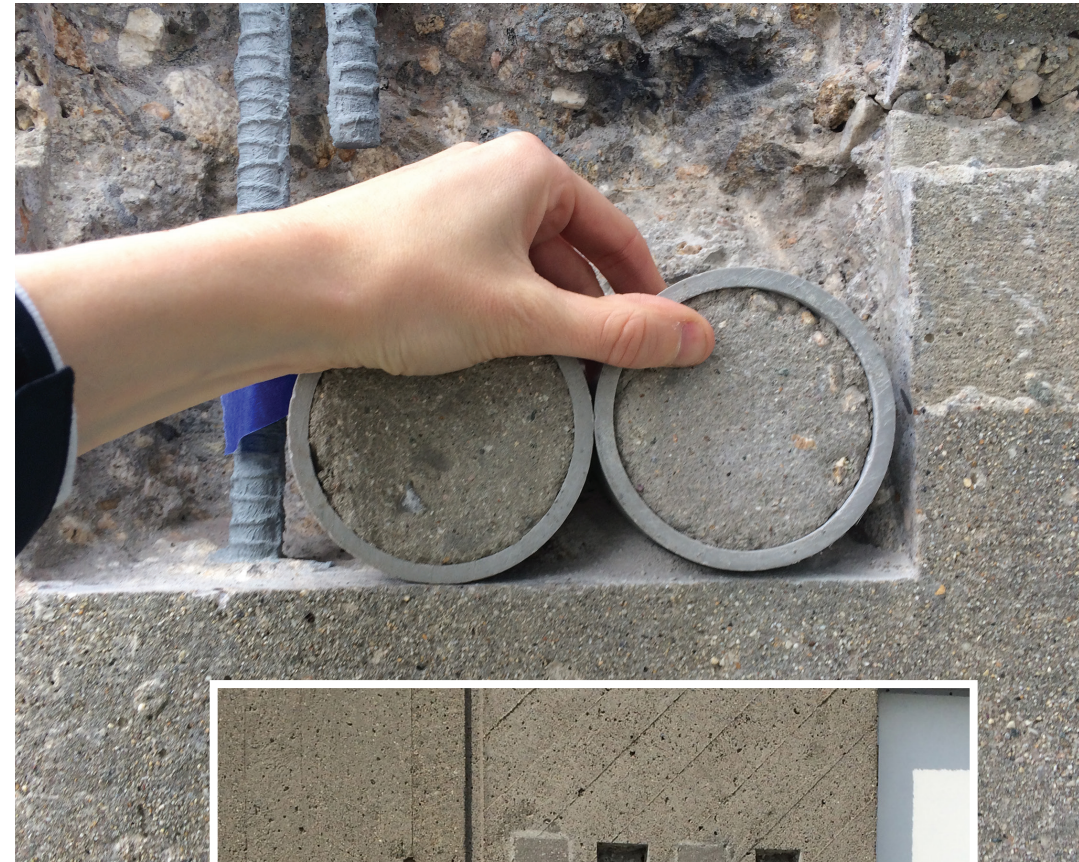
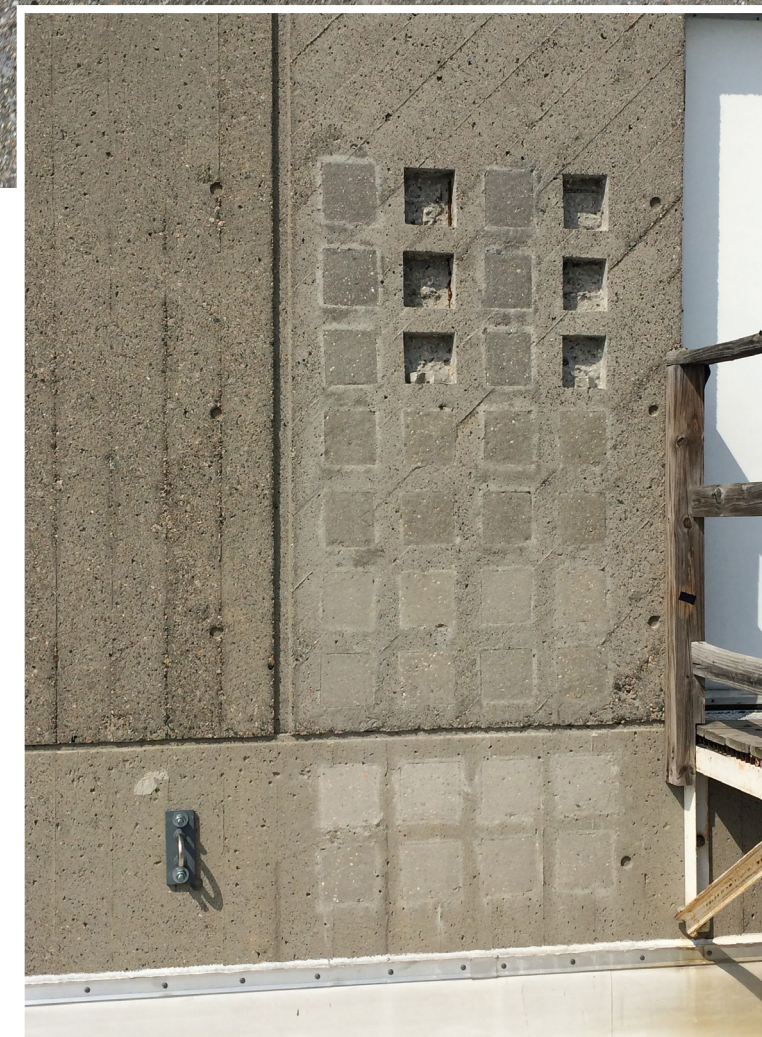
Pictured: puck samples (top), patch samples (right)

Patch specification may start with "puck" samples to compare mixes that have different paste and aggregate components. These may narrow the range of mixes to allow for in situ installations of the most promising candidates, but these typically involve six-inch-square insertions that need three or four weeks to cure for visual comparison. The comparison of refinements among mixes may require multiple successive installations and take several months to complete. Surface treatment that matches patches to adjacent surfaces is a hand craft, and masons need to show that they can consistently achieve the right finish. Even when clean, 45-year-old concrete does not look brand new again. Carbonation shifts tonality from gray to tan. Thin, brittle, cementitious laitance wears away to expose more aggregate, changing the concrete's texture and hue. Wet methods may involve contaminated run-off and ticketed disposal. Masons demonstrate their ability to match original surface textures in situ and are pre-approved for each project.

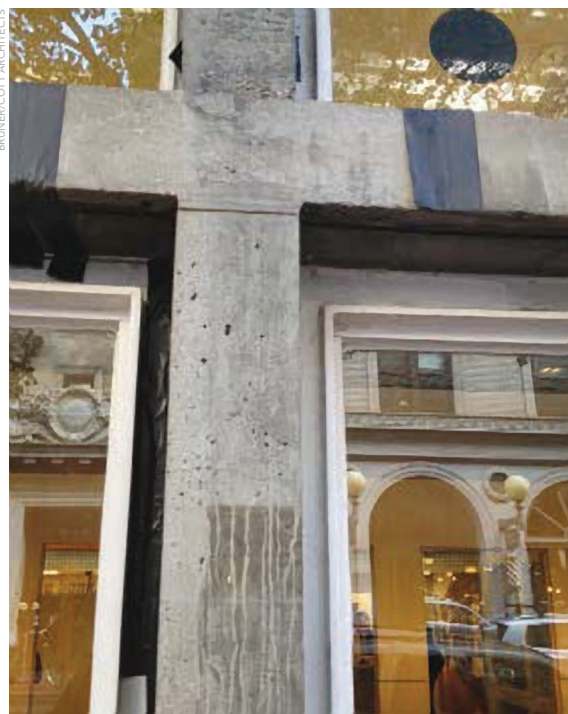
Pictured: concrete cleaning samples

In addition to the importance of a thorough survey with vertical access for sufficient sample areas to predict the amount of spalling, crack repair, and hazmat sampling, preconstruction is likely to involve a succession of concrete cleaning and repair test areas and in situ samples.

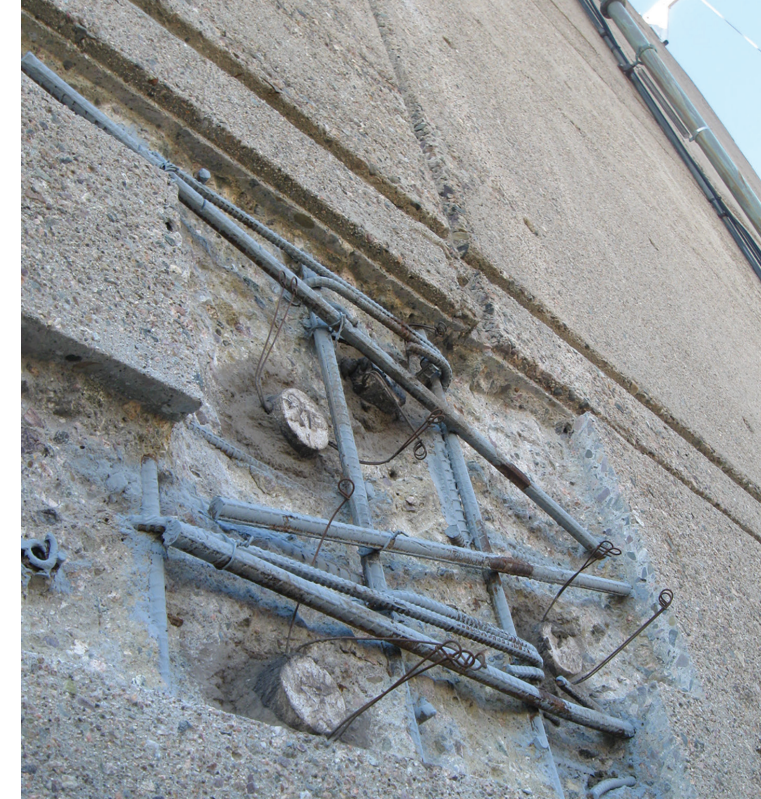
Exposed rebar or cut away concrete with rebars and anodes.

Cut and chipped concrete with exposed rebar and anodes

tural concrete are almost always associated with steel corrosion at places where water penetrates. Typically, rebars are too close to the exterior surface. Rust expansion causes cracks and incipient spalls. Full detachment of concrete spalls can pose a serious life safety threat to areas below. In these locations, concrete is cut away to expose the steel on all sides for coating with corrosion-resistant paint and with further removal to allow for insertion of a galvanic anode for passive cathodic protection and full coverage with new concrete.

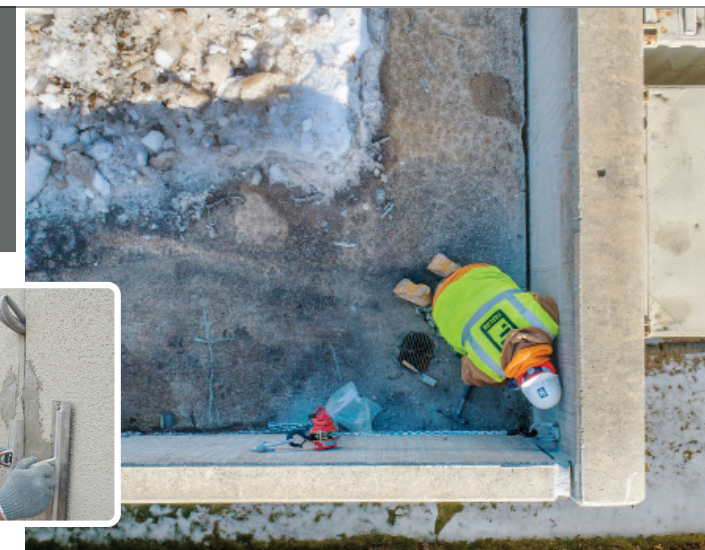
W2E realigned a spandrel panel after years of heavy snow had separated it from the rest of the deck.

Decades of plowing snow against spandrel panels on the top deck had caused separation and misalignment; previous repairs, patches, and caulking applications were aging; and double-T sections on the ceilings were cracked and stained. Though the structure was completed in the mid-1990s by a different contractor, the project was a perfect fit for Fabcon W2E.

dition to resolving the aesthetic issues, W2E pulled panels back into alignment, installed plates, replaced caulking, epoxied cracks, and removed and replaced aging deck patches. All in time for weekend shoppers to make their regularly scheduled run.

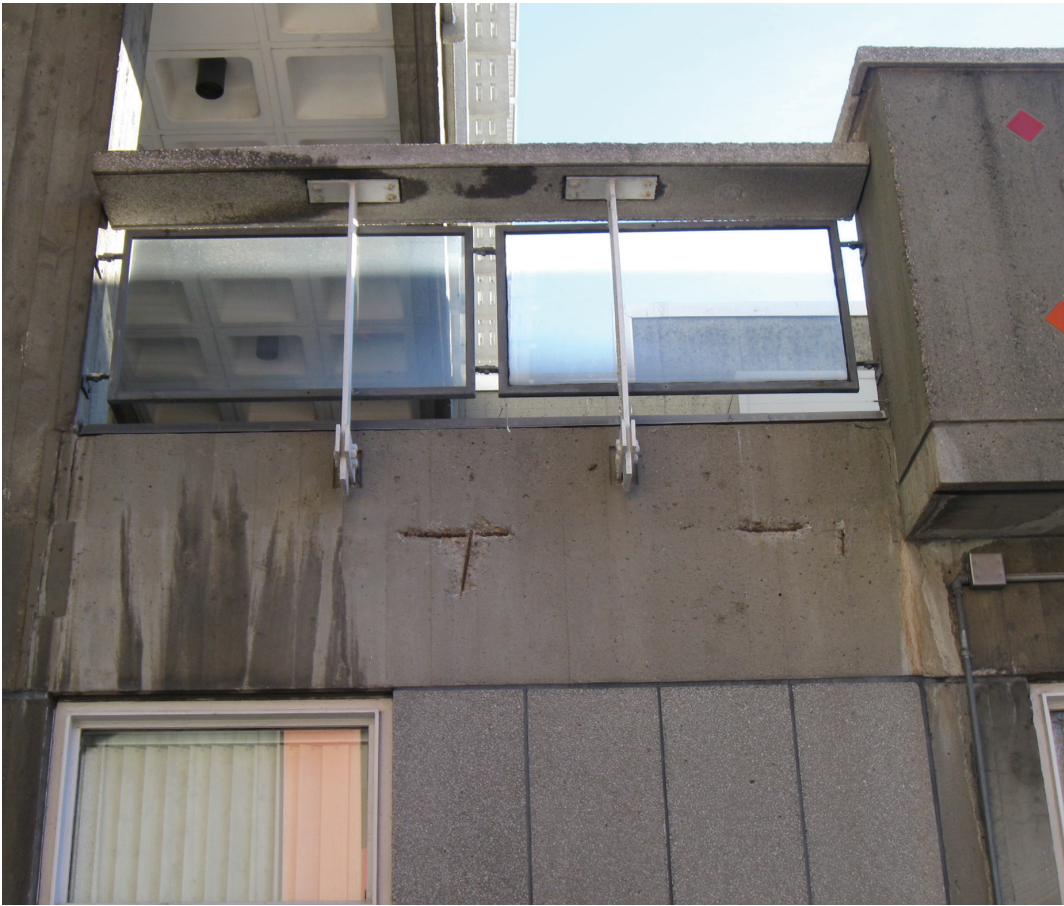
Five different surface treatments in one area of a concrete façade.

repairs. It is very difficult for patched concrete to match adjacent surfaces exactly, especially if the original is not cleaned. The "dutchman"

approach minimizes the distraction of individual patches and tonal discrepancy with their neighboring surfaces.
